Construction company fined after two workers injured in fall from height

A construction company has been fined after two workers were injured after falling through a ceiling at a site in Watford.

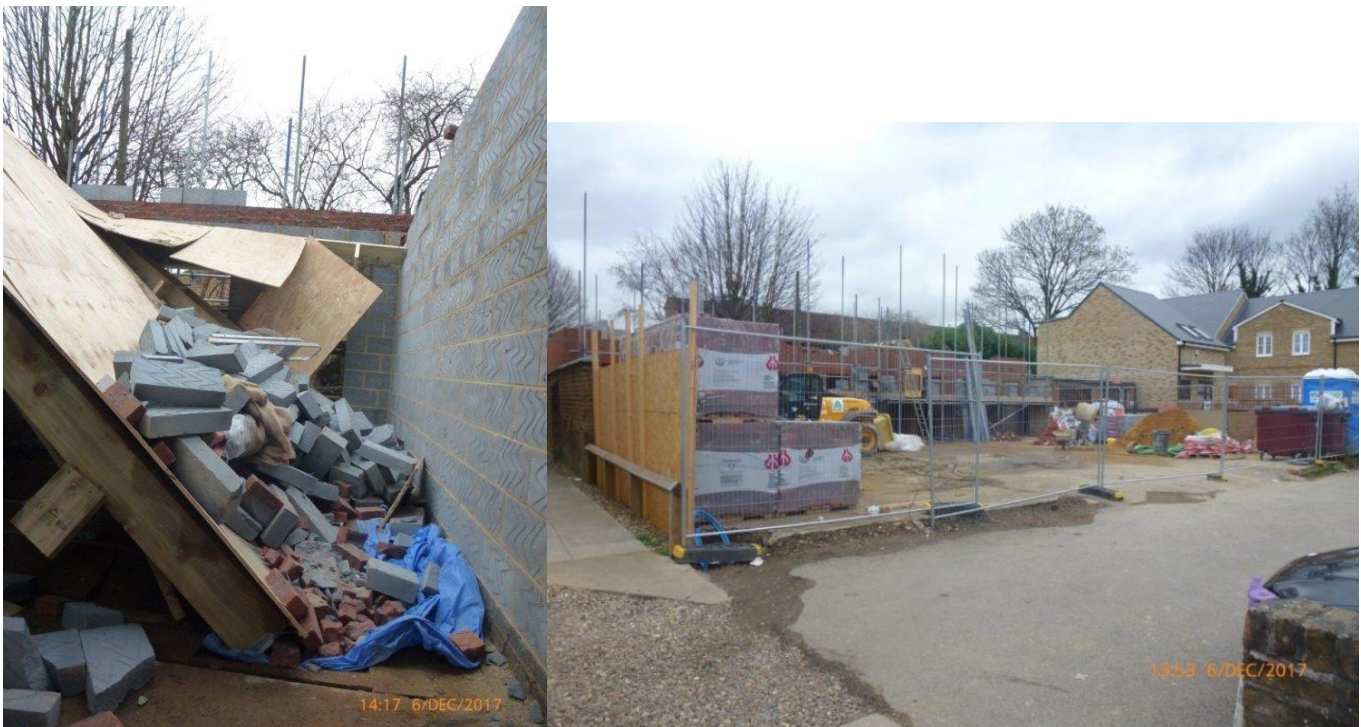
Both of the employees are still unable to return to full time work. One spent two days in hospital after the incident and the other is still recovering from his injuries; it is not clear whether or not his injury will be life changing.

An investigation by the Health and Safety Executive (HSE) found that the Principal Contractor, S McMurray Ltd, had failed to safely install joist hangers correctly. There was no other structural support arrangement in place, such as propping the first floor from underneath. The floor was also overloaded with blockwork.

After the hearing, HSE inspector Rauf Ahmed said: “Structural stability of floors under construction must be carefully risk assessed to ensure the appropriate control measures are in place to prevent collapse.

“ This incident could have been prevented had there been a sufficient risk assessment in place and the appropriate controls implemented.”
