Excavation:

What you need to know as a busy builder

Getting in too deep?

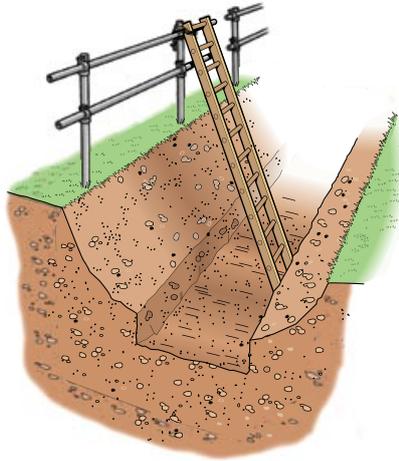
A simple trench with sides battered back to 45° (guard rails on right hand side omitted for clarity)

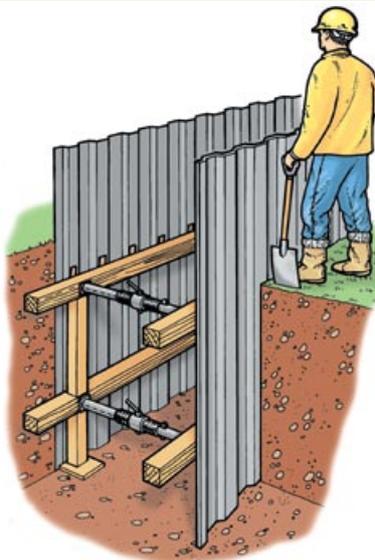
Trench sheets with timber walings, screw props, puncheons and sole plates

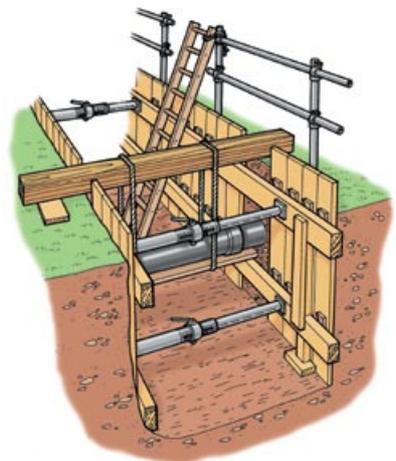
An example of a shored excavation with ladder access and supported services (guard rails on left hand side omitted for clarity)

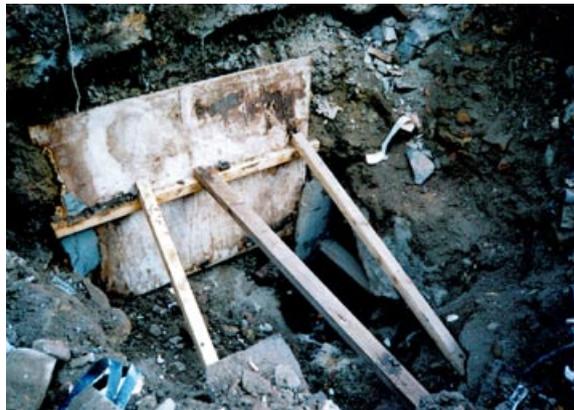
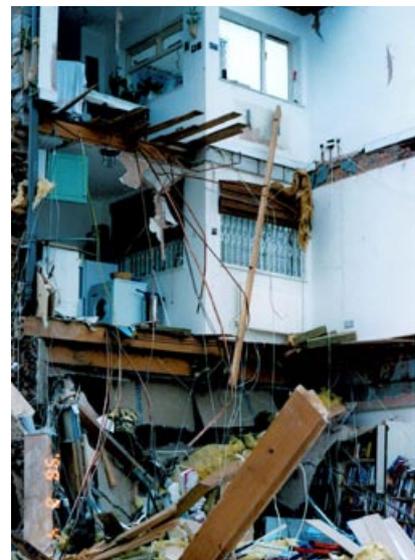
Inadequate shoring of this excavation and others like it led to the collapse of an adjoining 3-storey property (see picture, right). Luckily, no one was injured.
